THE STANTON HOUSE

Historic Structure Report

Women's Rights National Historical Park
Seneca Falls, New York

Barbara A. (Pearson) Yocum
Building Conservation Branch, Northeast Cultural Resources Center
Northeast Region, National Park Service
U.S. Department of the Interior
Lowell, Massachusetts

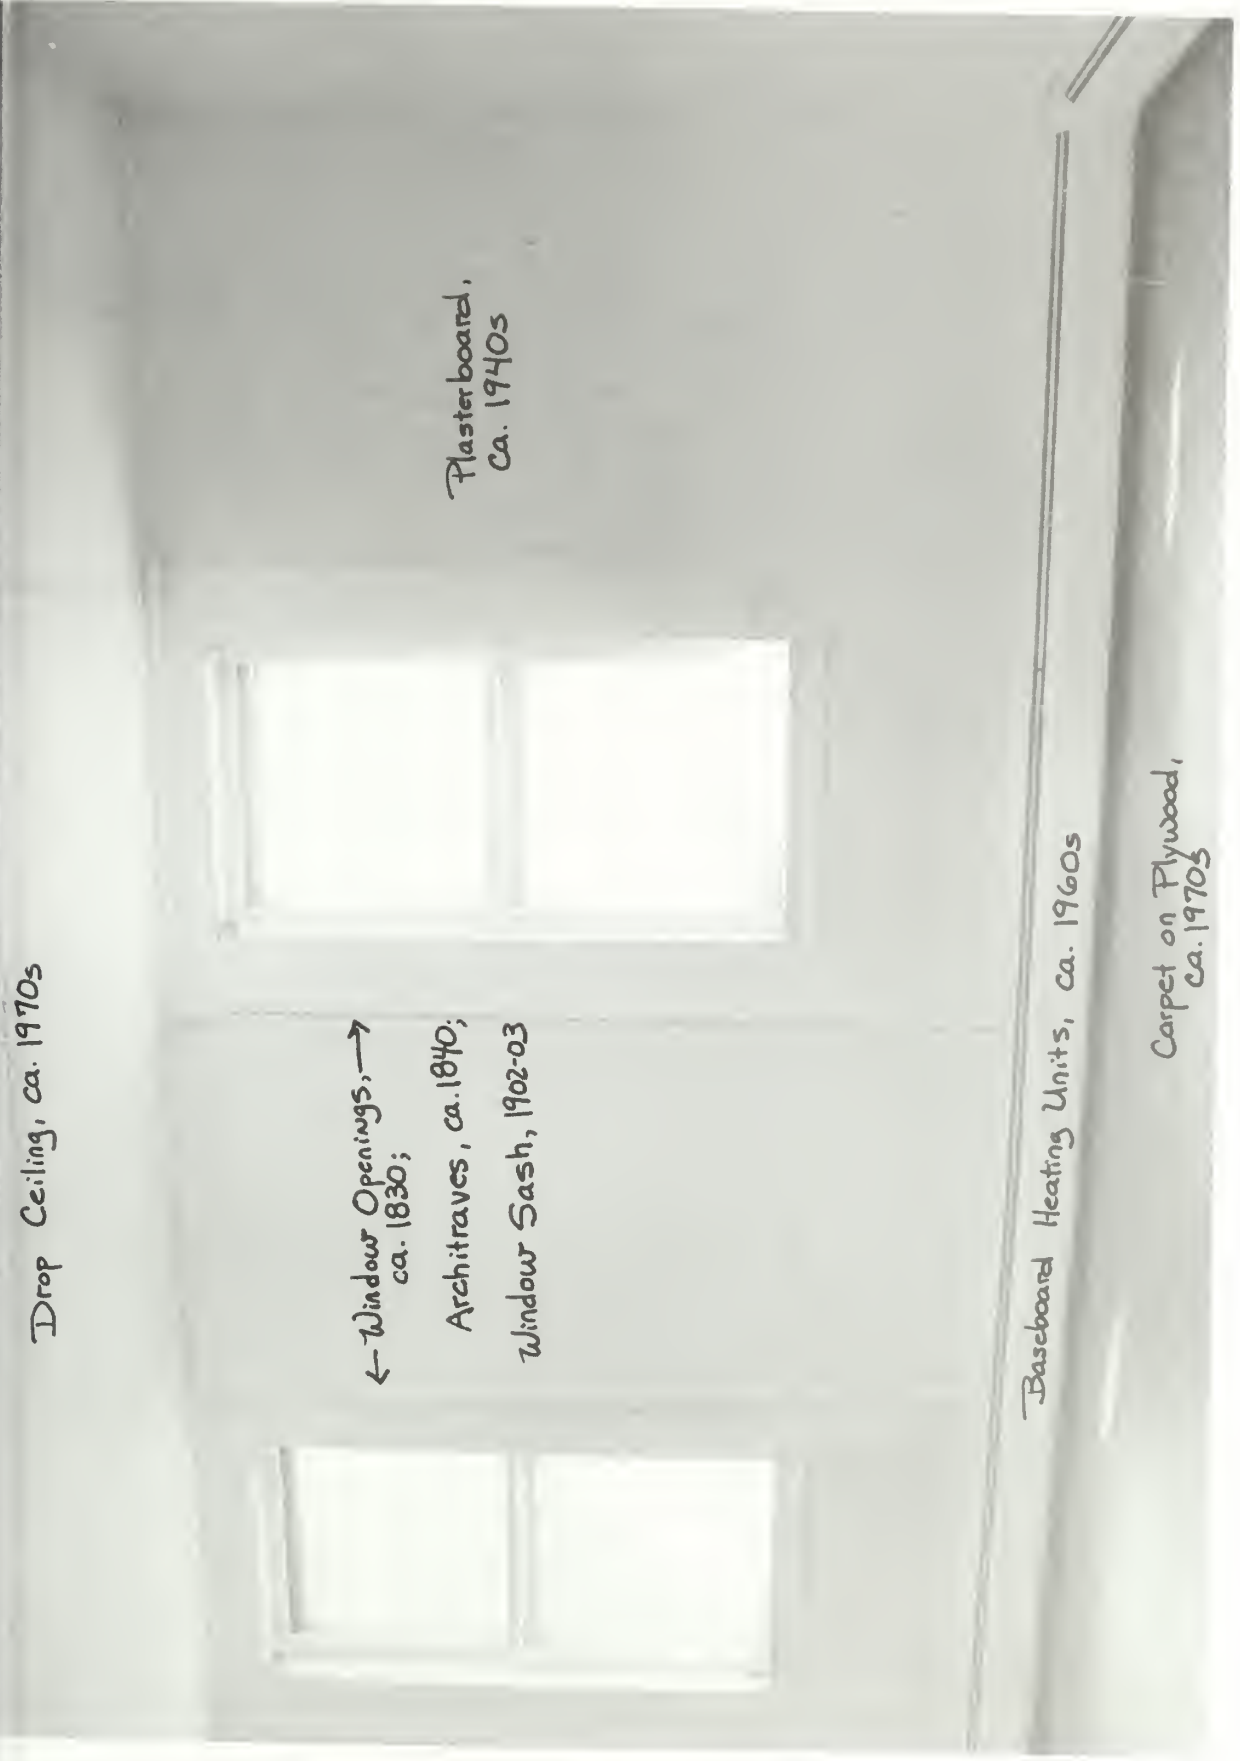
Figure 37. Stanton House: Room 101, looking west, June 1982.

Drop Ceiling, ca. 1970s

← Window Openings, →
ca. 1830;

Carpet on Plywood,
ca. 1970s

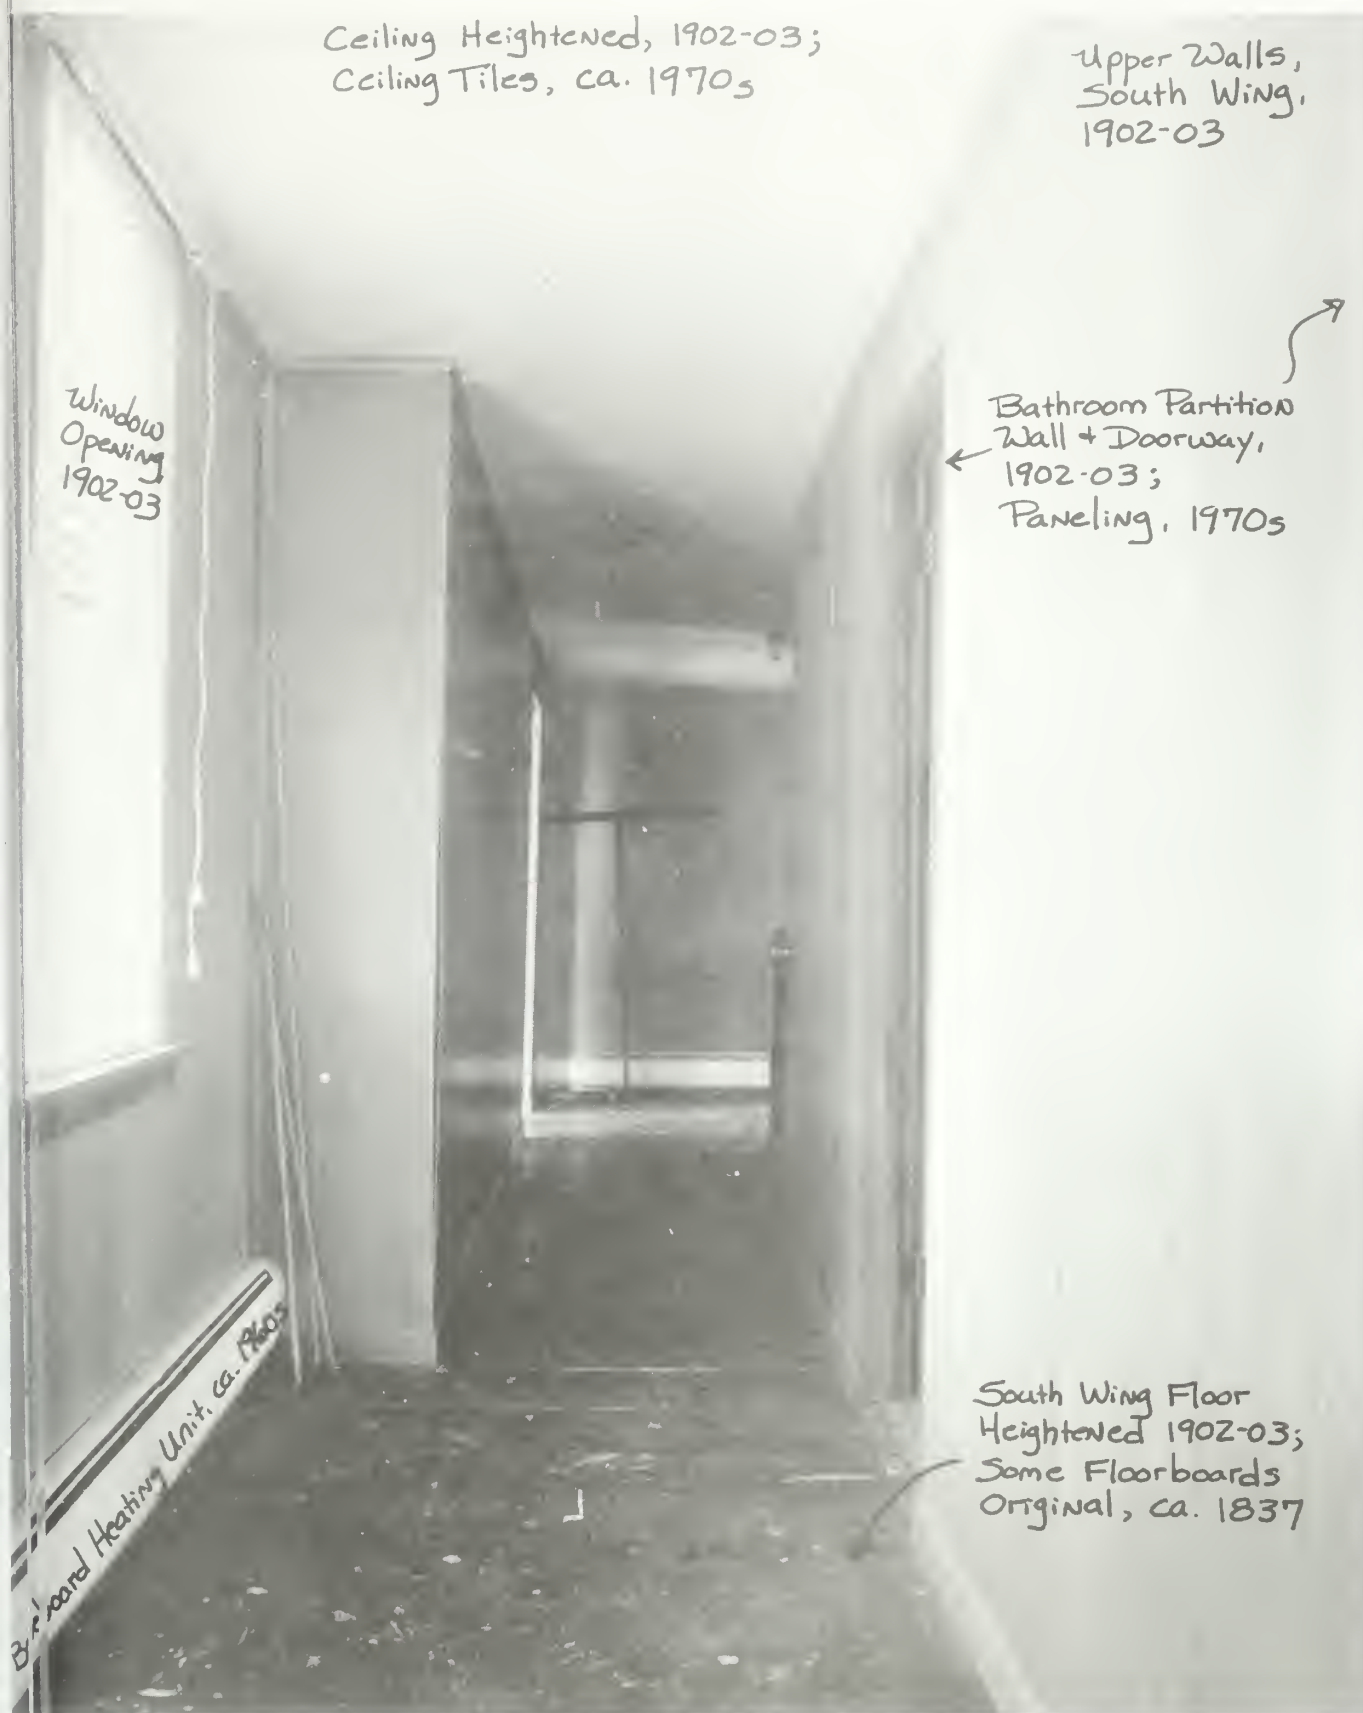
Figure 57. Stanton House: second-story hall looking north, June 1982.

Ceiling Heightened, 1902-03;
Ceiling Tiles, ca. 1970s

Upper Walls,
South Wing,
1902-03

South Wing Floor
Heightened 1902-03;
Some Floorboards
Original, ca. 1837

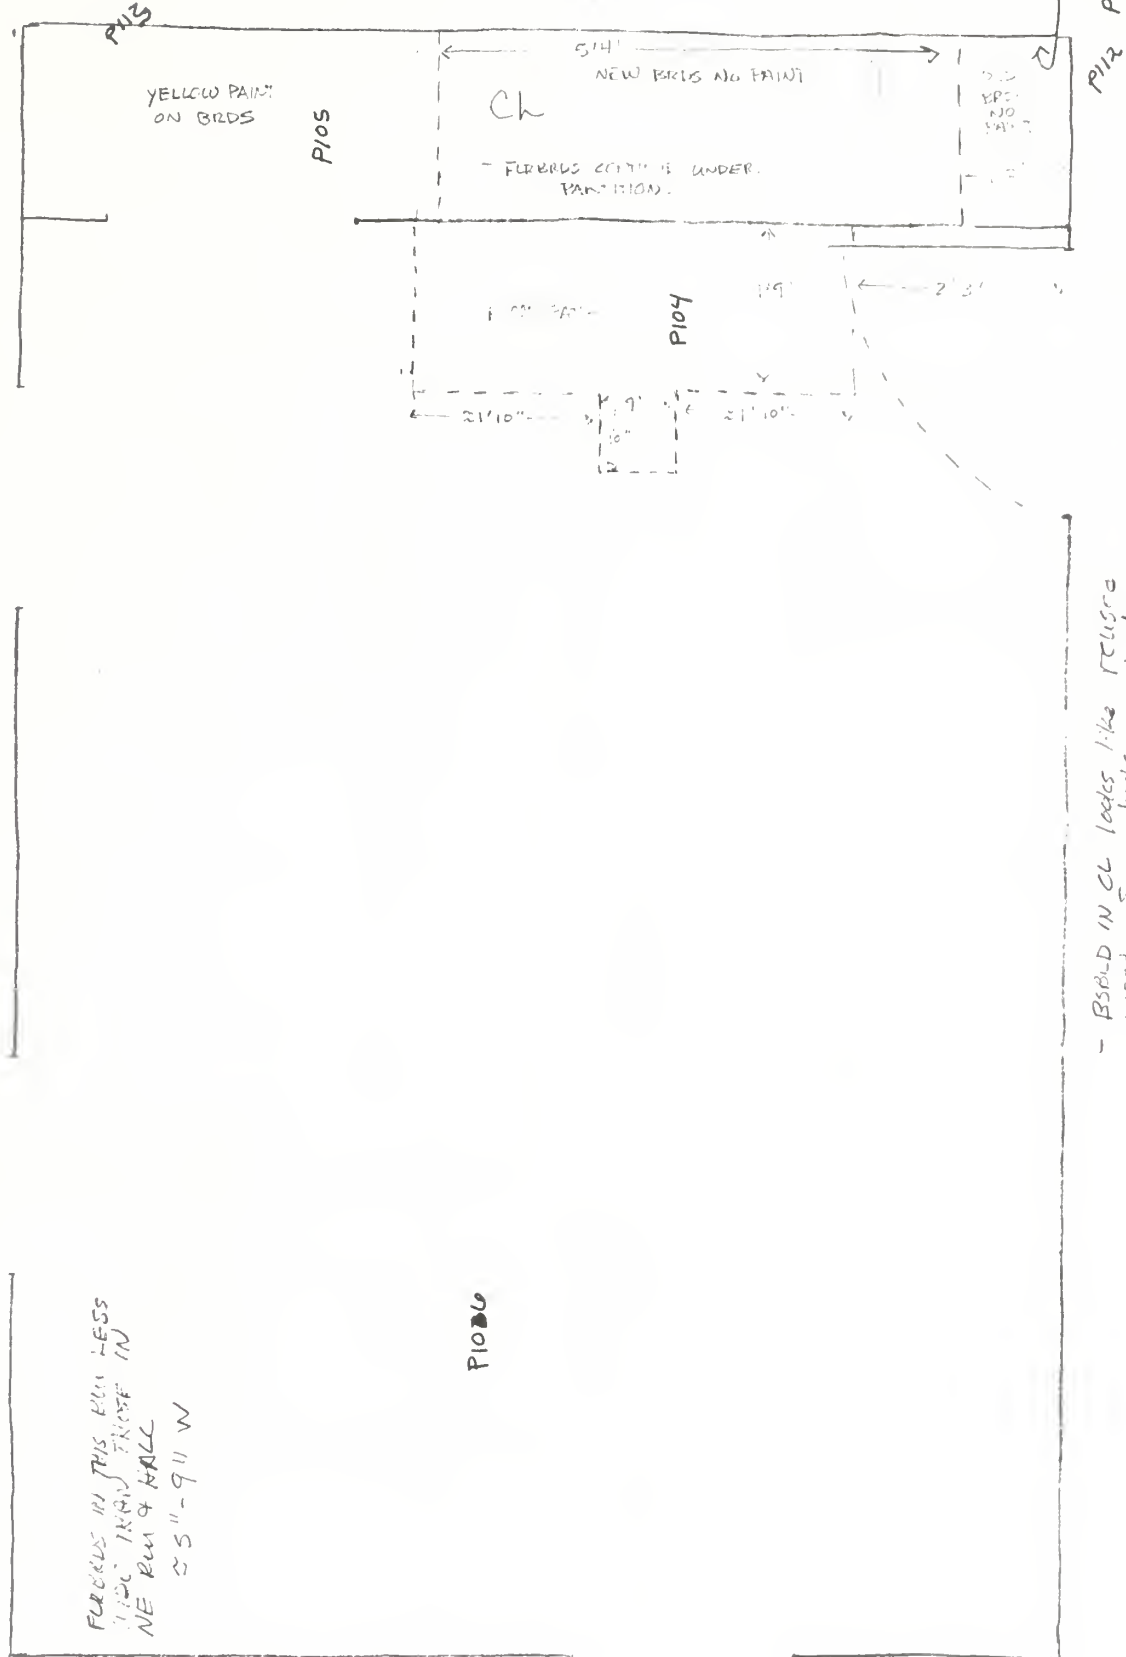
STANTON VS
WEST PA - 2ND FLR.
7 JUNE 82. RM 201

- BIRDS IN CL looks like reused wood some birds painted, some not. no pattern
